Docket No. 217 – Development and Management Plan Inspection

Northeast Utilities Service Company Certificate of Environmental Compatibility and Public Need for the construction of a 345-kV electric transmission line and reconstruction of an existing 115-kV electric transmission line between Connecticut Light and Power Company's Plumtree Substation in Bethel, through the towns of Redding, Weston, and Wilton, and to the Norwalk Substation in Norwalk, Connecticut.

Date: September 13, 2006

Location: 345kV Underground Route

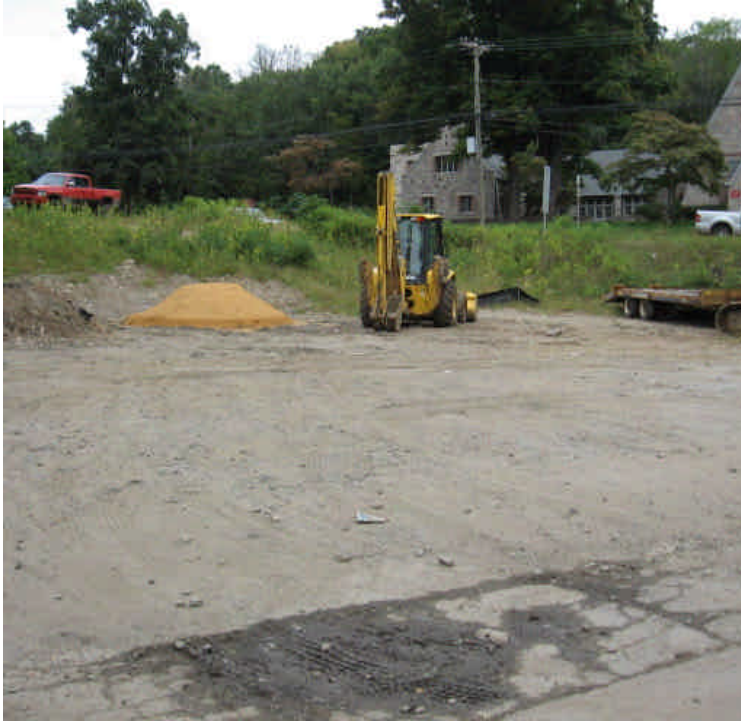
345kV: Photo on the left shows some grading and demobilization at the storage yard across from Old Highway Rd. Photo on the right shows grass growth starting at the recently stabilized vault area near Old Danbury Rd. 9/13/06

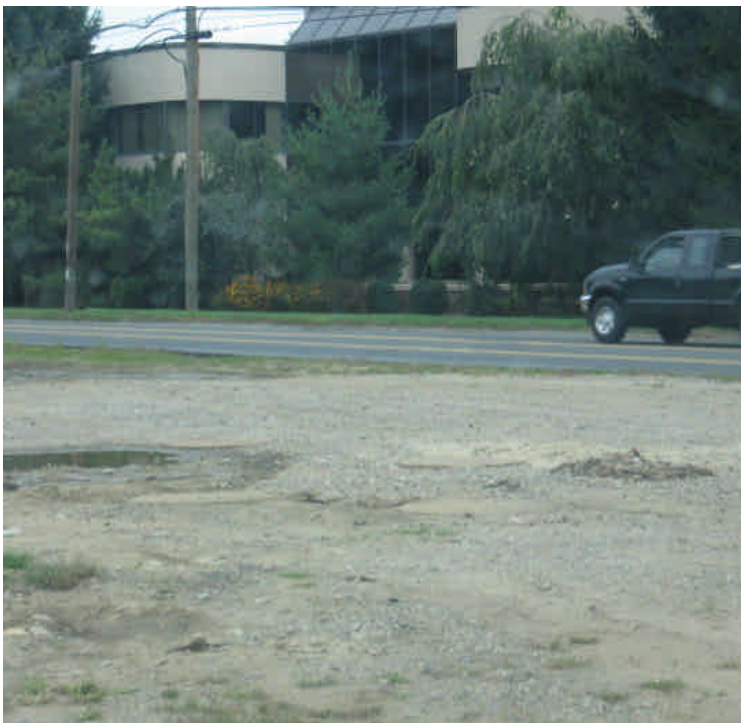
Photo on the left shows the remaining bare area near the Wilton HS tennis courts that will need restoration prior to the end of the growing season. Photo on the right shows the School Rd site where vehicles unrelated to the project had caused tracks in the yard. 9/13/06

Areas of Inspection	Observation	Recommended Action	Corrective Action
Vault Openings and Trench Construction	<ul style="list-style-type: none"> - Most work areas along Rt. 7 have been restored but a few bare areas remain or have not re-vegetated as well as expected. This includes in front of the tennis courts at Wilton High 8/24-9/13/06 -A number of vaults continue to be accessed along portions of the route for internal work 9/13/06 - Active work continues at the Rt 7/107 intersection. Catch basins in the area do not have controls and there is adjacent disturbed soil. 8/24-9/13/06 - Portions of the areas were restored. 9/13/06 	<ul style="list-style-type: none"> - Continue providing good "house- keeping" along the roadways. Full restoration will be required when work is completed. 2/2-9/13/06 - Topsoil, seed and mulch will be needed here. - Include these areas as part of the restoration efforts when access is complete. 4/12-9/13/06 -See erosion control section. 8/16-9/13/06 	<ul style="list-style-type: none"> -Needs attention (near Wilton HS tennis courts) -N/A - Some areas were restored but needs further attention.

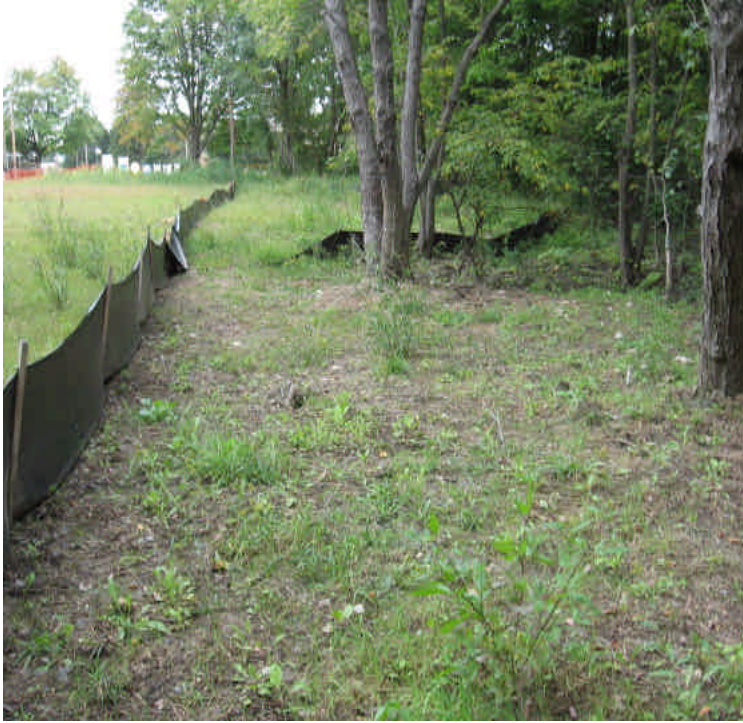
Photo on the left shows the wetland area to the east of the HDD continuing to revegetate. Wetland species were noted along this area and adjacent to the swale. Photo on the right shows the storage area near the Rt 107/7 intersection which has demobilized. The disturbed area has been restored.

Areas of Inspection	Observation	Recommended Action	Corrective Action
Erosion and Sediment (E&S) Controls Route 7	<ul style="list-style-type: none"> - At the School Rd. HDD, areas along the perimeter wetlands remain in good shape. Vegetative cover continues to slowly increase in the mulched area to the east. 8/24-9/13/06 - A large bare soil area remains near the Wilton HS tennis courts. Previous attempts had been made to restore the area but were unsuccessful. 8/30-9/13/06 - Controls at Old Danbury Rd. are in good shape and some grass growth was noted. Vault access was also occurring. 9/13/06 - The vault area at Wilton Corp Park was temporarily restored but access created new tracks in the soil. 8/30-9/13/06 	<ul style="list-style-type: none"> - Continue to monitor for final stabilization. 8/17-9/13/06 - Loam, seed and mulch this area. Also, evaluate the grading since water is ponding up here. 8/30-9/13/06 -Continue to monitor for final stabilization. 9/13/06 Also consider removing accumulated sediment in the swale. 7/12-9/13/06 -Restore as necessary and monitor for final stabilization. 8/30-9/13/06 	<ul style="list-style-type: none"> -N/A - Needs attention when feasible. -N/A -Needs attention when feasible

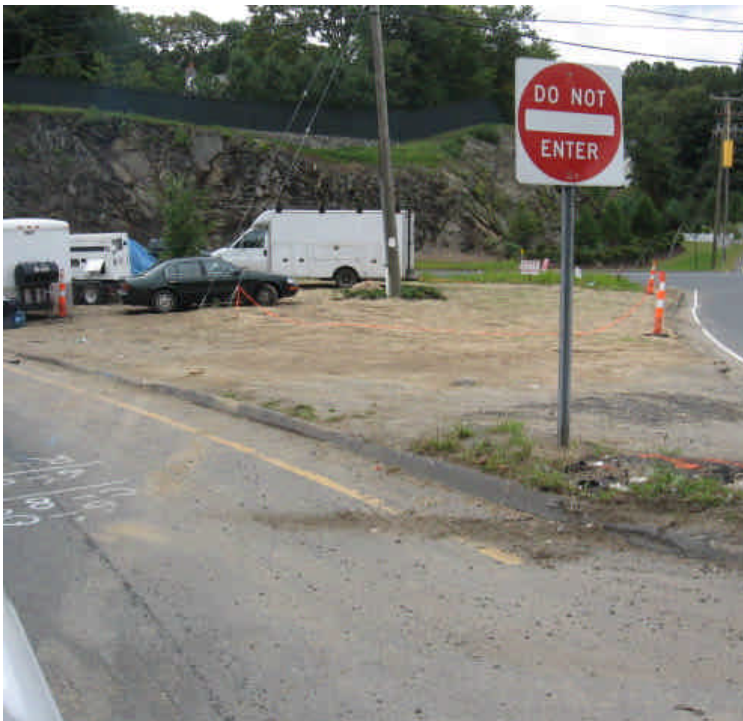
Photo on the left shows continuing work at the vault at the Rt 107/7 intersection. Portions of the area had been restored but adjacent catch basins still need controls. Photo on the right shows a view of the silt fence installed at the Gilbert & Bennett lot. Seed and mulch are still needed here along the slope. 9/13/06

Rt. 107	<ul style="list-style-type: none"> - Restored areas at the storage area near #848 (Rt.7) were beginning to show grass growth. 9/13/06 - Catch basins near the Rt. 107 & 7 intersection do not have filters/ controls in place. Some disturbed soil is present. The area has been disturbed for several months prior to work returning here 7/12-9/13/06 - At the Georgetown Deli J&B, vegetative growth continues at all of the restored areas and the boulders are holding up well. 9/13/06 - At the Georgetown HDD site (Gilbert & Bennett lot), 	<ul style="list-style-type: none"> -Area appears to be stabilized and grass will continue to grow. 9/13/06 - Install controls in the catch basins and restore the island when access is complete. 4/6-9/7/06 - Portions of the island are restored with seed and mulch. 9/13/06 -Very good vegetative growth is noted in all restored locations. Banks appear stable. 9/13/06 - Seeding and mulching 	<ul style="list-style-type: none"> -N/A - Needs attention Portions were restored. -Banks appear stable
